FIG. 255.—LOWER DAM, OR "PRESA DE LA OLLA," GUANAJUATO, MEXICO. VIEW TAKEN DURING THE FEAST DAY WHEN THE GATES ARE RAISED AND THE RESERVOIR EMPTIED.

The chapter on Masonry Dams has been increased twofold by an attempt to make some mention of all the most notable dams of the world, and many that are very little known. Attention is particularly directed to Plates 1, 2, and 3, in which profiles are shown of all of the leading and better known masonry dams in existence, drawn to uniform scale for easy graphical comparison. No such complete collection of dam profiles has ever before appeared in print, assembled together on a common basis.

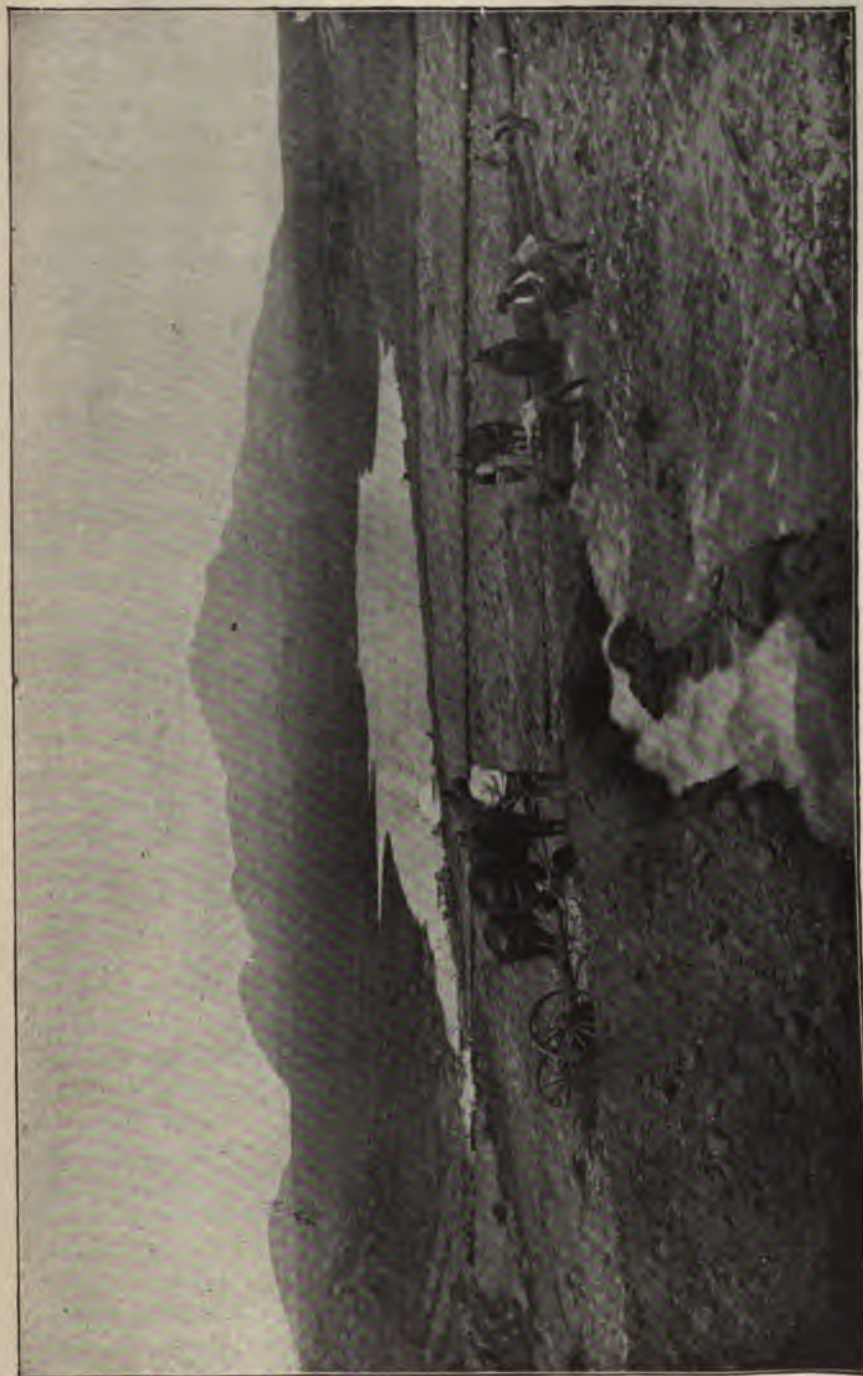
FIG. 71.—LA MESA (CAL.) DAM IN COURSE OF CONSTRUCTION BY THE HYDRAULIC PROCESS.
Showing method of loosening earth to get it in suspension before taking it into carrying conduit. The conduit was built in 24-foot sections, which could be and were frequently taken apart and moved as conditions required.

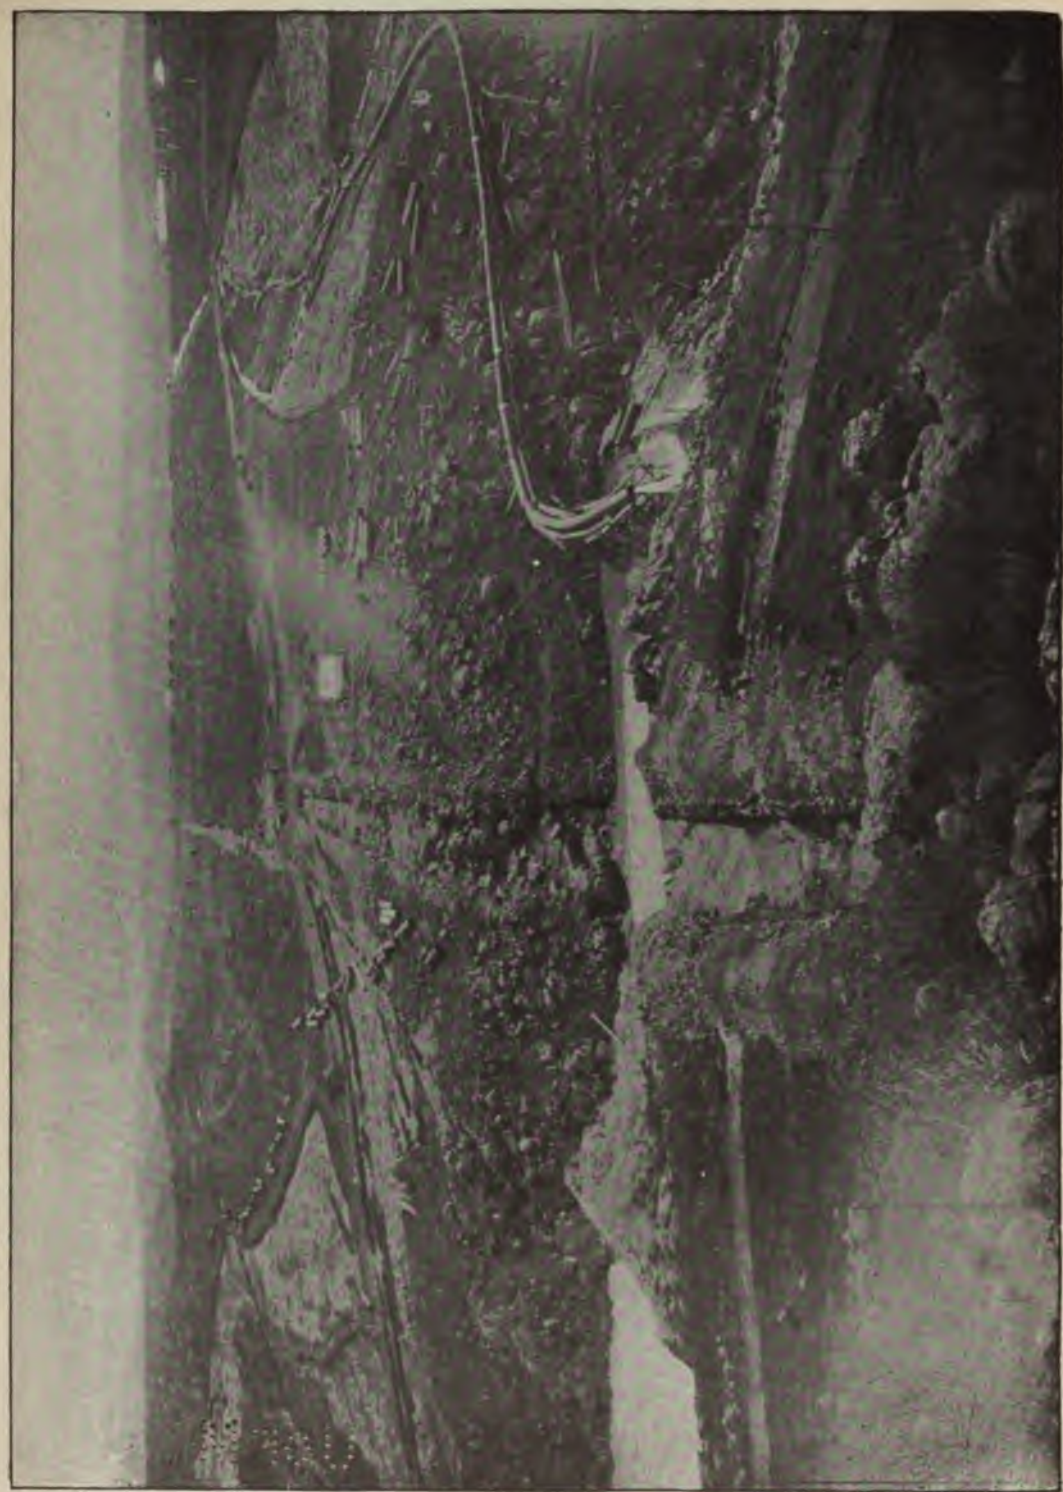
FIG. 72.—LA MESA RESERVOIR. BEGINNING OF THE CONSTRUCTION OF HYDRAULIC-FILL DAM.

In beginning the work a trench was excavated in bed-rock, as shown in Fig. 72, from 2 to 5 feet deep, 20 feet wide at center and tapering to 5 feet at the ends. At right angles to this trench in the bed of the gulch a culvert was built to reach entirely through the dam at its widest point. This culvert, whose details are shown in Fig. 73, consisted of a concrete conduit, 48 inches wide, 30 inches high, extending from the inner face of the dam outward 180 feet, to a point 72 feet from the lower toe, where it connects with two 24-inch cast-iron pipes, that form the outlet to the reservoir. One of these pipes connects with a wood-stave pipe supplying water to San Diego, and the other is used as a waste, or clean-out, pipe. Both are controlled by gate-valves at the toe of the dam. The walls of the concrete culvert are 12 inches in thickness, and four vertical stand-pipes connect with the culvert at intervals of 35 feet from the inside end. These stand-pipes consist of 24-inch vitrified pipes, surrounded with concrete, which pass upward through the body of the dam, and are now used as outlet-pipes to the reservoir at four different levels. During construction they performed the important function of conveying the water into the reservoir after it had dropped its load of gravel and sediment on to the surrounding embankment. They were built up a joint at a time in 2-foot sections, as the work progressed, and were finished off at the top with brass ring and flap-valve, the latter being controlled by rods reaching up the slope through the water to the surface. (See Fig. 70.) These flap-valves can only be opened when pressure is relieved by closing the gate-valves below.

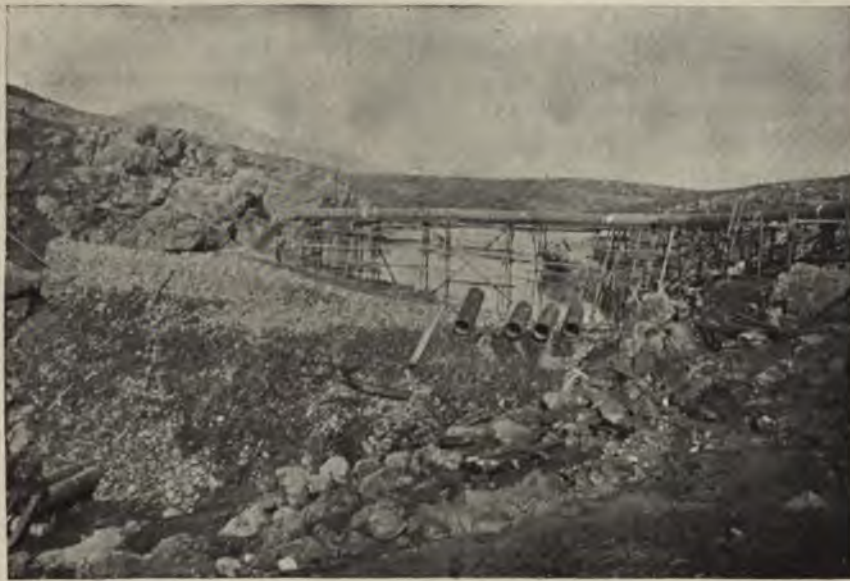
FIG. 76.—LA MESA HYDRAULIC-FILL DAM, SHOWING PIPE DISCHARGING MATERIAL ON THE DAM.

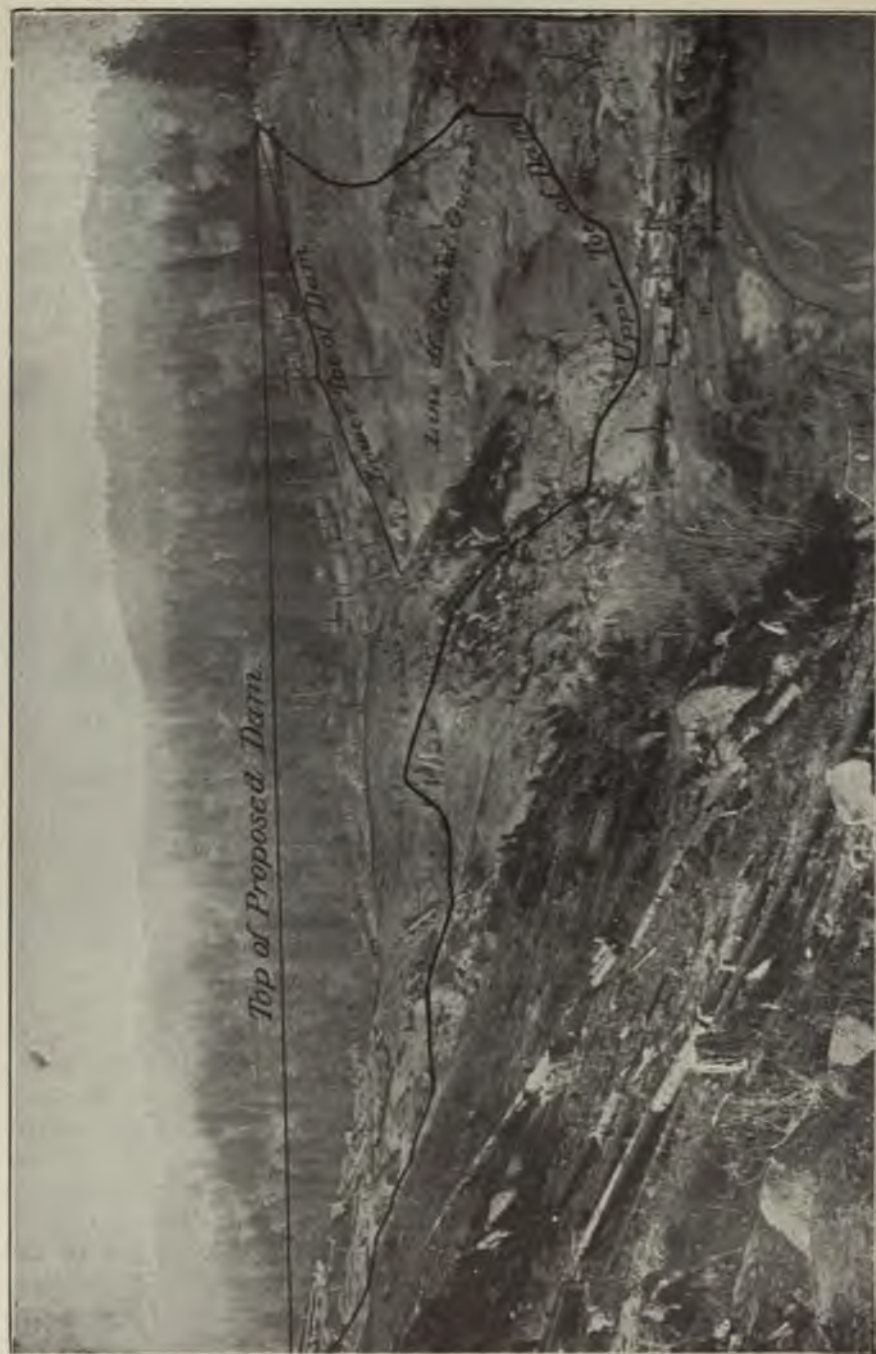
FIG. 77.—VIEW OF CRANE VALLEY DAM-SITE, SHOWING OUTLINES OF HYDRAULIC-FILL DAM.

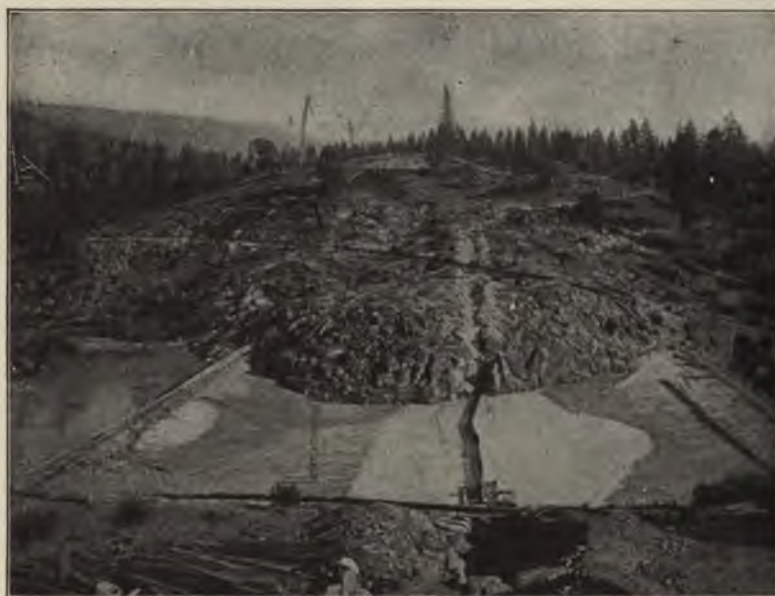
FIG. 79.—CRANE VALLEY DAM. SHOWING WOODEN FENCE, OR CENTER DIAPHRAGM, WHICH WAS CARRIED UP TO A HEIGHT OF 30 FEET ABOVE BED-ROCK.

1-inch surfaced sheeting. This wooden partition was continued to a height of some 30 feet above the base of the dam, its object being mainly to prevent the stratification of material deposited by the water from extending across the center of the dam from either side. It was also designed as a check against percolation through the dam.

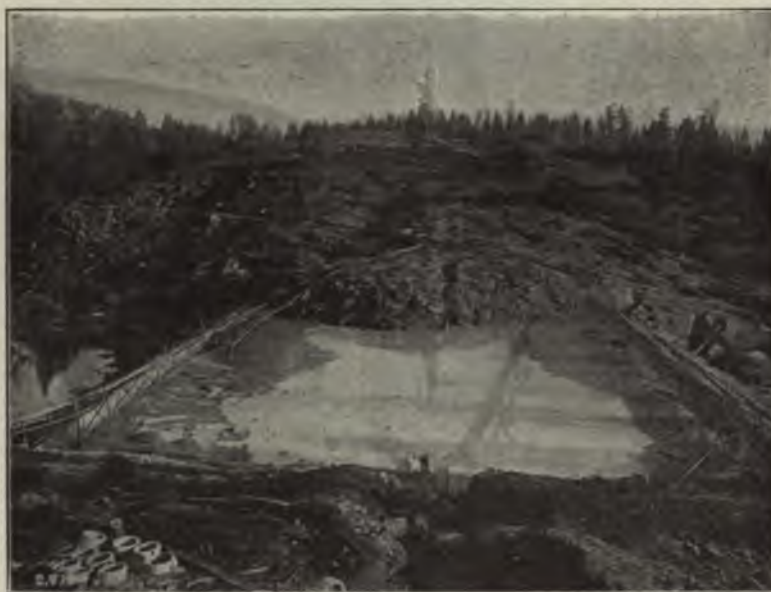
FIG. 80.—CRANE VALLEY DAM SHOWING DISCHARGE OF SLUCED EARTH AT END OF CONVEYING FLUME.

water with its load, was made at convenient points by side gates in the flume, formed of a short section of the side board sawed in such a way that it could be swung across the flume, turning out the entire flow at that point. From these points of discharge the sand and silt were distributed on light grades until the central pool was reached, when precipitation of the sand took place at once, forming bluff banks under the water near its edge, while the fine silt particles were distributed across the pool.

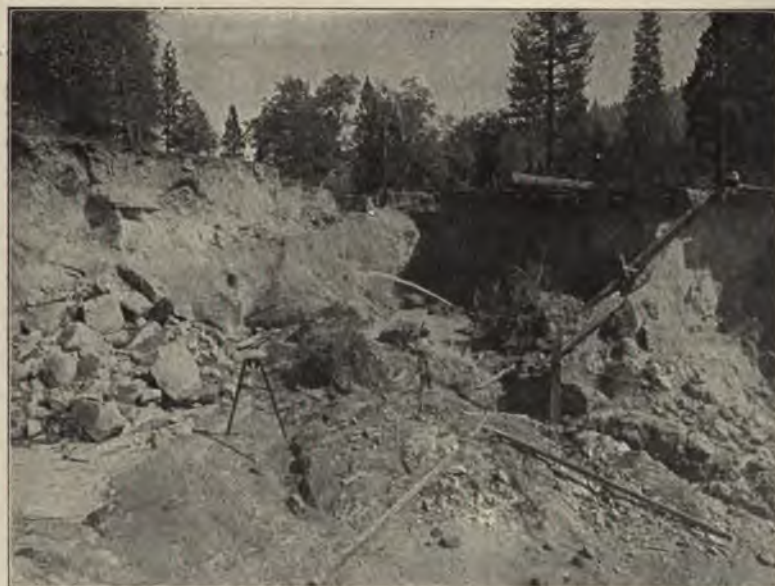
FIG. 81.—CRANE VALLEY HYDRAULIC-FILL DAM. SHOWING METHOD OF LOOSENING THE MATERIALS SLUICED INTO THE DAM.

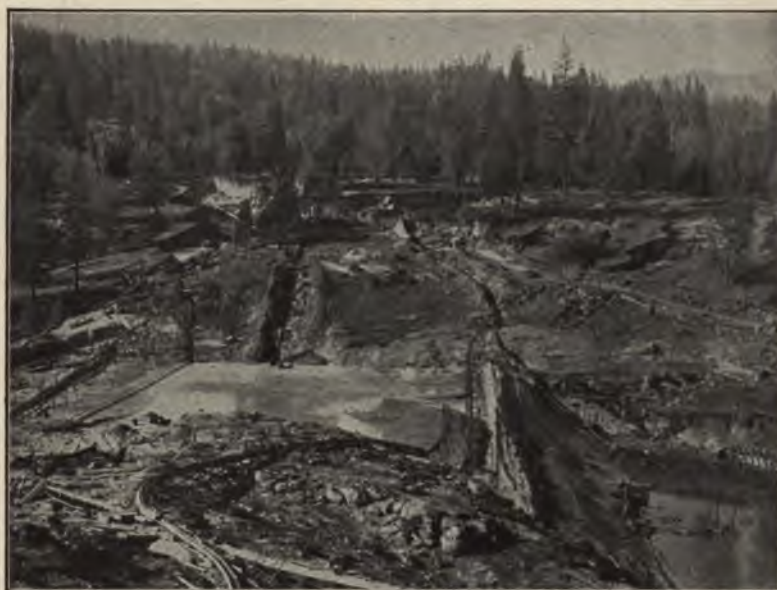
FIG. 82.—BORROW-PITS FROM WHICH MATERIAL WAS SLUCED TO THE CRANE VALLEY DAM IN BACKGROUND.

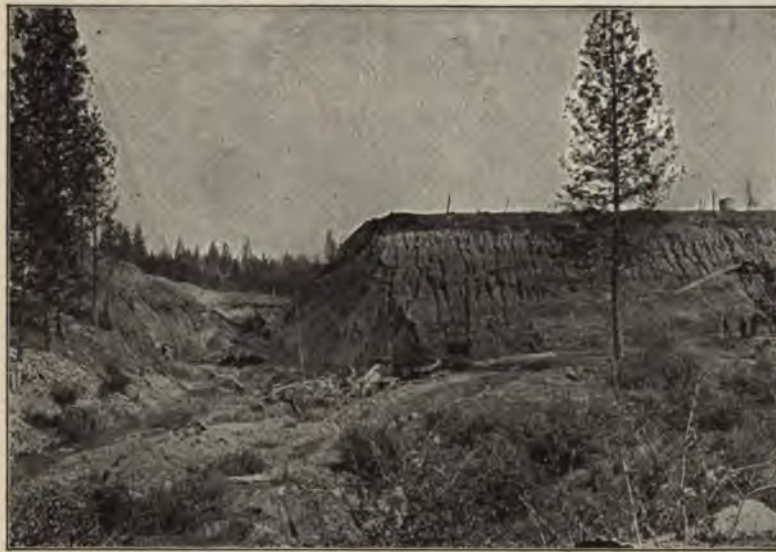
FIG. 84.—BREAK IN ORIGINAL LAKE FRANCES DAM. LOOKING UP STREAM.

and when the water had risen to within six feet of the spillway level, at 11 A.M., Oct. 21, 1899, the dam was suddenly ruptured, and a hole washed through it 100 feet wide at top, extending down to and below the original stream-bed. The dam originally contained 80,265 cubic yards, of which 16,160 cubic yards, or about 20%, were washed away.

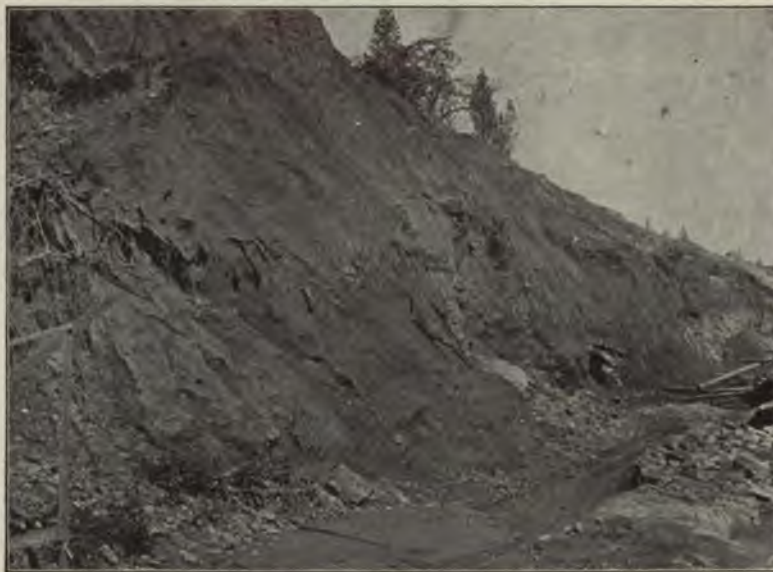
FIG. 85.—NEAR VIEW OF RIGHT SIDE OF BREAK IN EMBANKMENT OF LAKE FRANCES DAM SHOWING ROOTS EXPOSED BY THE BREAK.

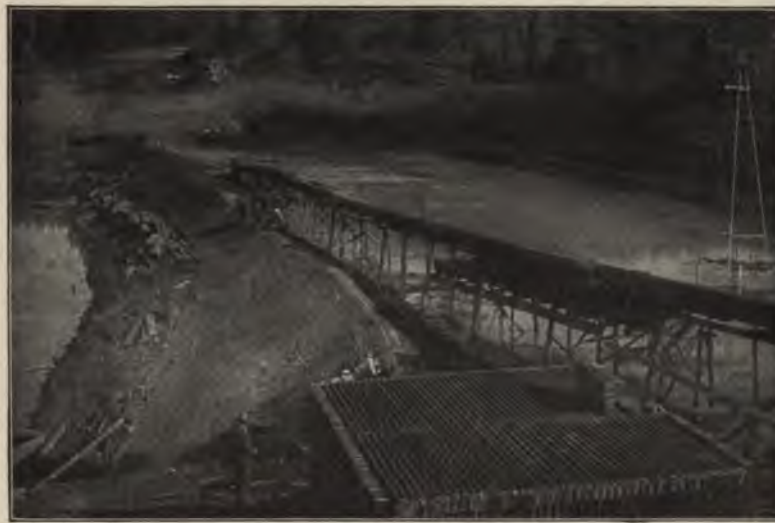
FIG. 86.—TOE LEVEE OF NORTH FACE, LAKE FRANCES DAM, AND INLET CRIB AT HEAD OF FIVE-FOOT OUTLET CULVERT.

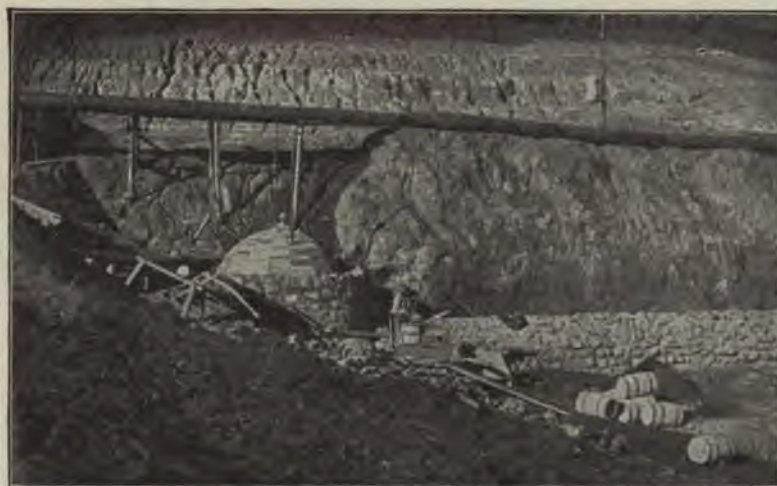
FIG. 87.—DOME ON GATE CHAMBER, LAKE FRANCES DAM; ALSO TWENTY-TWO-INCH SLUICE PIPE.

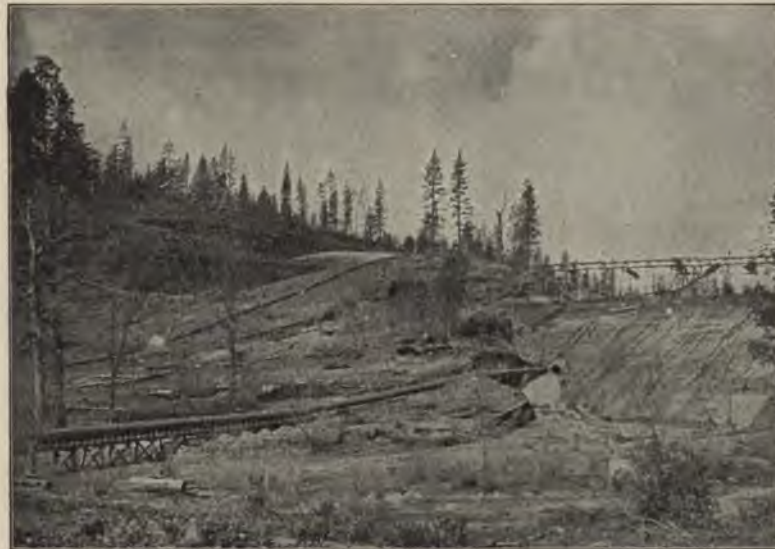
FIG. 88.—WEST END OF LAKE FRANCES DAM, SHOWING THE BREAK RESTORED, THE HIGHER DAM NEARLY COMPLETED, THE HYDRAULIC GIANT AT WORK, AND THE MAIN PIPE LINE SUPPLYING WATER TO THE PUMP.

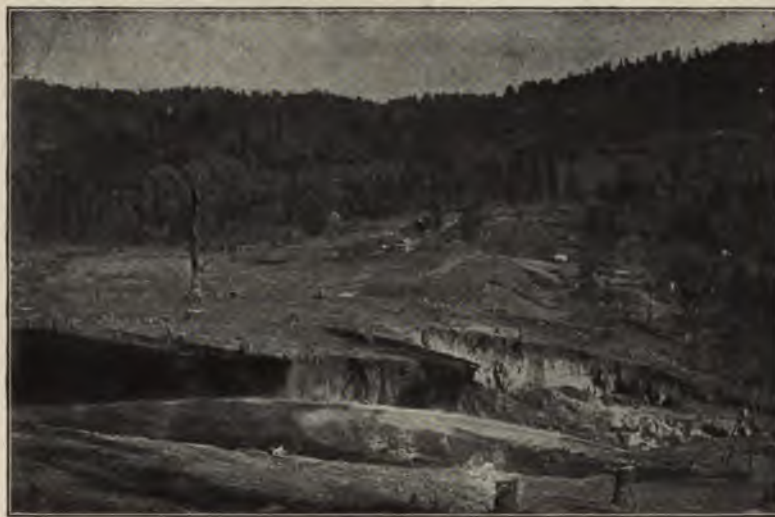
FIG. 90.—LAKE FRANCES DAM, NOVEMBER 6TH, 1901. FROM SOUTH BORROW-PIT, LOOKING ALONG AXIS OF ORIGINAL DAM.

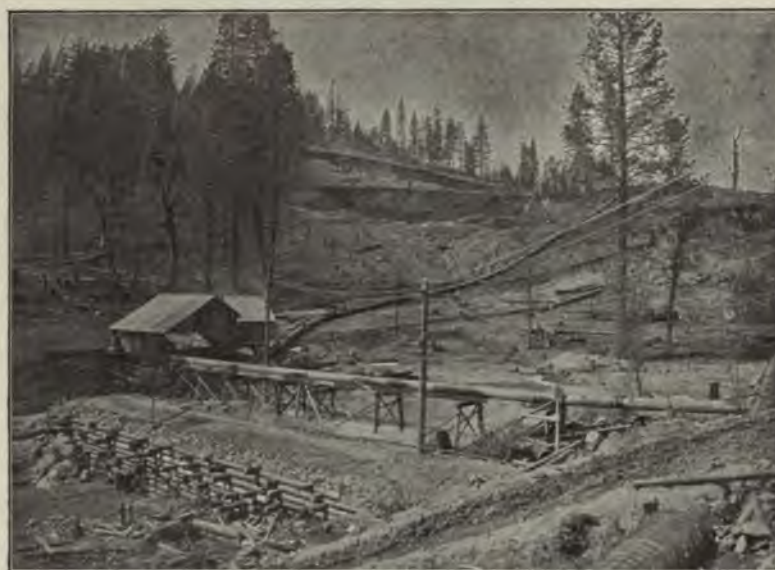
FIG. 91.—LAKE FRANCES DAM CONSTRUCTION. PUMPING STATION, SHOWING SUCTION PIPE CONNECTED TO TANDEM CENTRIFUGAL PUMP. CRIB DAM IN FOREGROUND BUILT TO STORE WATER FOR EARLIER OPERATIONS.

Sluicing with a Pump.—As a gravity water-supply was not obtainable it became necessary not only to pump the water for sluicing, but to build a small storage-reservoir below the dam to store up a supply and pump the water over and over again. Owing to delay in completing the two-stage tandem centrifugal pump (one half of the large pump referred to) on account of a machinists' strike in San Francisco, work was begun on a small scale May 10, 1901, with a 6-inch single-stage centrifugal pump, direct connected to a 30-H.P. motor, installed with

pipe, 300 to 700 feet long. The pump was belt-connected with a 350 H.P. synchronous motor, using alternating electric current at 2400 volts.

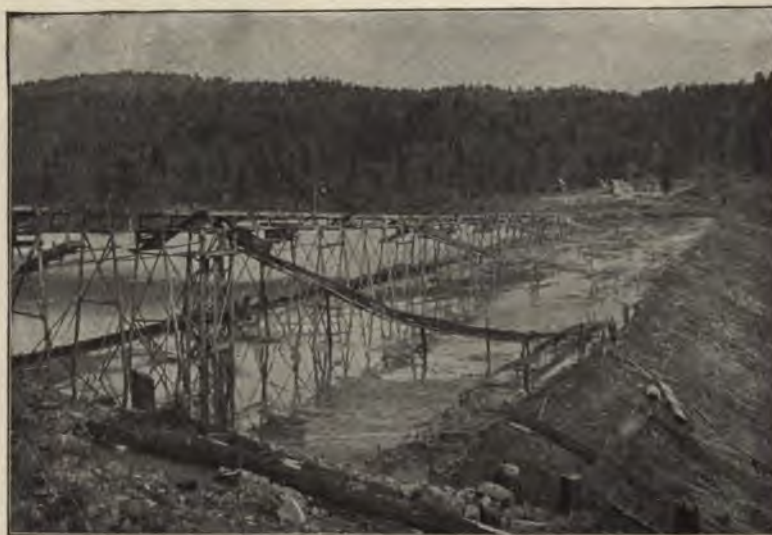
FIG. 92.—LAKE FRANCES, CAL., HYDRAULIC-FILL DAM BUILDING. SHOWING OUTER LEVEES MAINTAINED WITH BRUSH, DEFLECTING BOARDS FOR DISTRIBUTING SLUICINGS ALONG SLOPE, GENTLE SLOPES TOWARD CENTER OF DAM, AND GRADUAL MOVEMENT OF DRAINAGE TOWARD EXTREME END.

enough inside the slope lines to make delivery through lateral flumes of moderate length, terminating at the edges of the rising embankment. They were of varying length, according to the height at which they were designed to deliver, and were made about 25 feet in average height. The longest trestle with which the additional height of 25 feet above the original dam was built was 1560 feet long, with 13 branch trestles, as shown in Fig. 92. The highest bent in this trestle was 40 feet high.

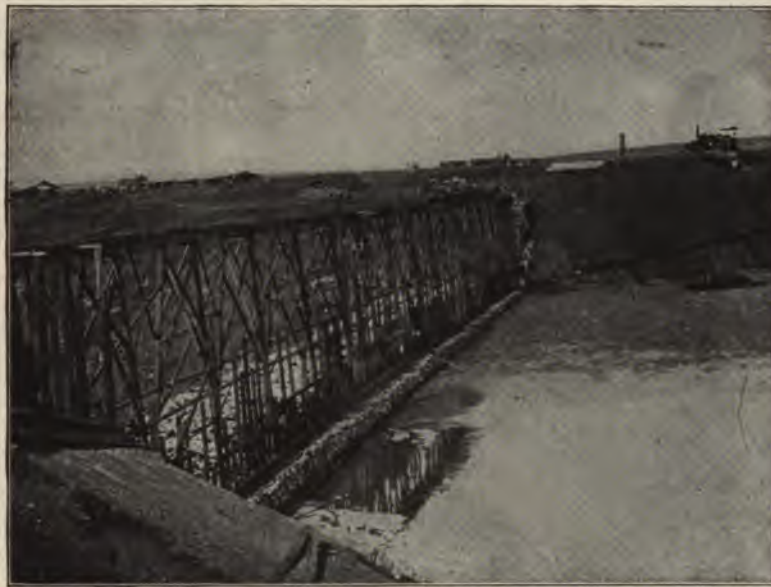
FIG. 95.—WAIALUA DAM, SHOWING HYDRAULIC-FILL BEING SLUICED IN AGAINST THE ROCK-FILL.

They were dumped from the top of a trestle built at the outset to the full height of the dam (see Fig. 95), and the larger stones selected from the dump for laying up the faces of the wall. The height from which the rocks were dropped consolidated the embankment quite effectively, so that little or no settlement has been noticeable since the completion of the dam, although shortly before completion the outer facing wall, some 2 feet thick, bulged out about a foot beyond the slope line over a limited area, indicating that some settlement had occurred. This was corrected

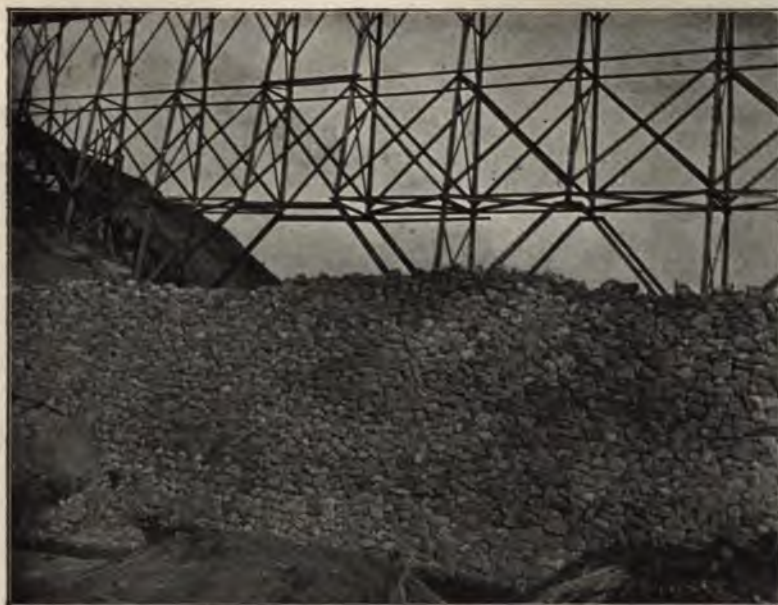
FIG. 96.—ROCK-FILL ON DOWN-STREAM SIDE OF WAIĀLAE DAM.

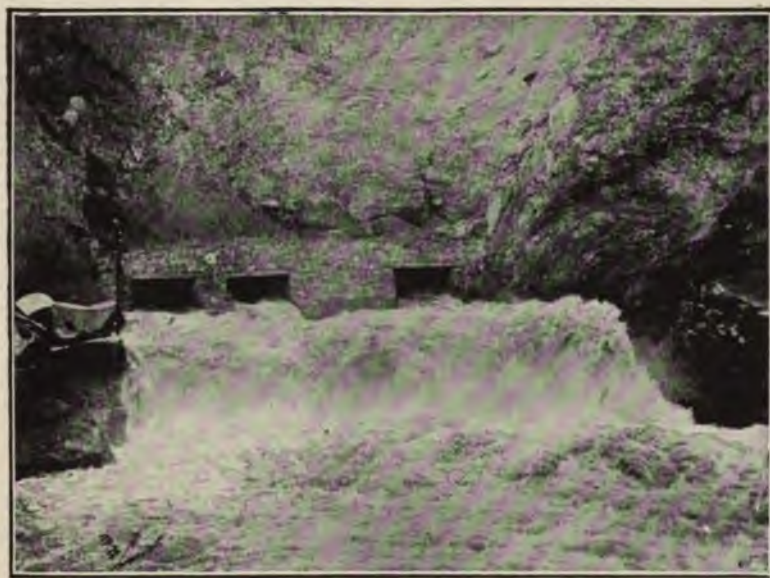
FIG. 97.—WAIĀLAE DAM, HAWAII, SHOWING FLOOD DISCHARGE THROUGH OUTLET TUNNELS DURING CONSTRUCTION, UNDER HEAD OF 8 FEET AT UPPER END OF TUNNELS.

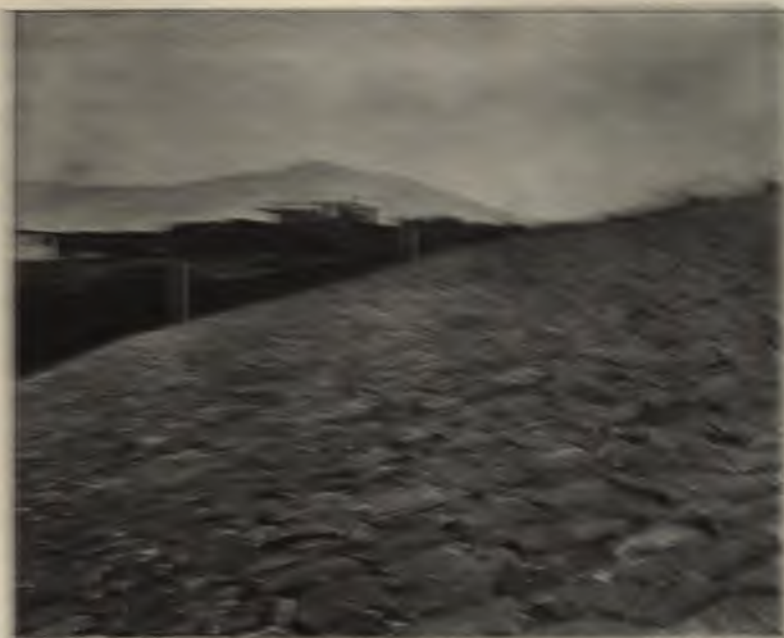
FIG. 98.—REPAIR ON FACE OF HYDRAULIC-FILL, WAIALUA DAM.

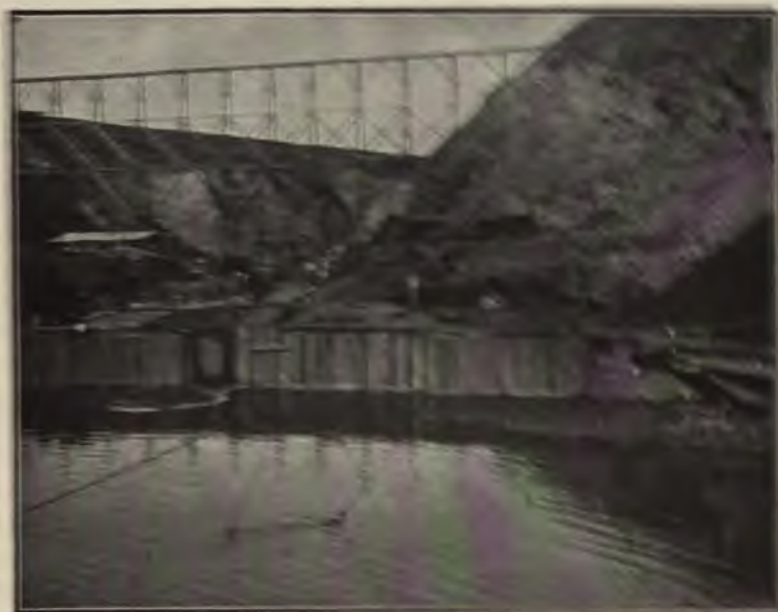
FIG. 99.—WAIALUA DAM, HAWAII. LOOKING DOWN-STREAM THROUGH DAM-SITE, SHOWING DIVERTING DAM AT UPPER TOE, AND TRESTLE FOR MAKING THE ROCK-FILL.

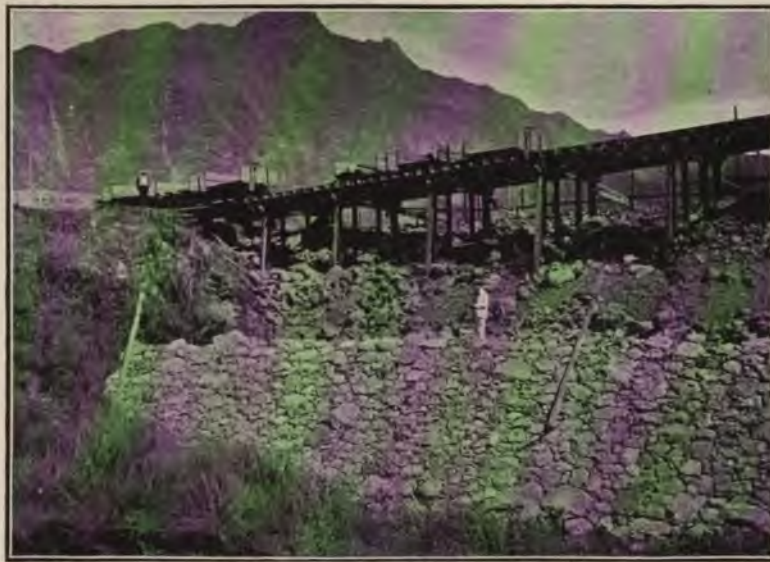
FIG. 100.—NUUANU DAM, HONOLULU, SHOWING TOE OF ROCK-FILL PORTION OF DAM.

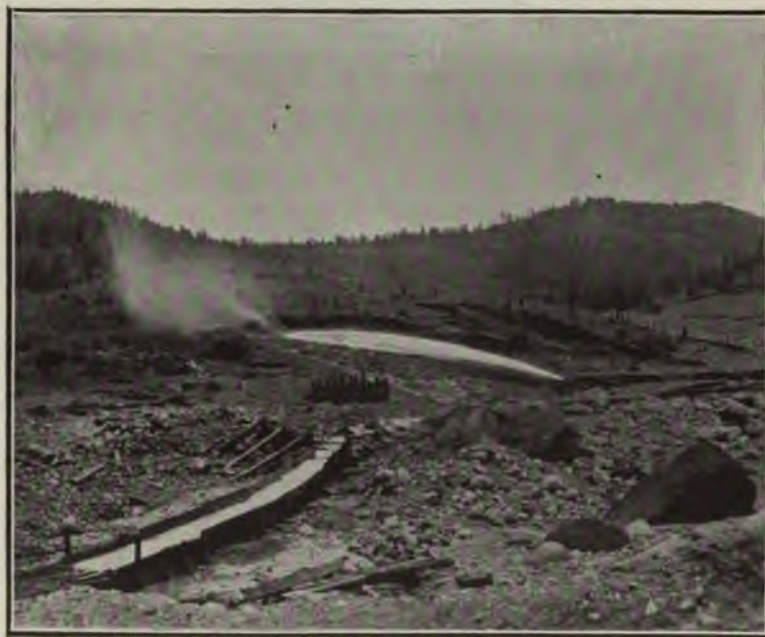
FIG 104.—TERRACE DAM, COLORADO, LOOKING UP-STREAM. ILLUSTRATING GRADATION OF MATERIAL TOWARD THE CENTER OF THE DAM FROM THE POINT OF DEPOSIT AT THE SLOPES.

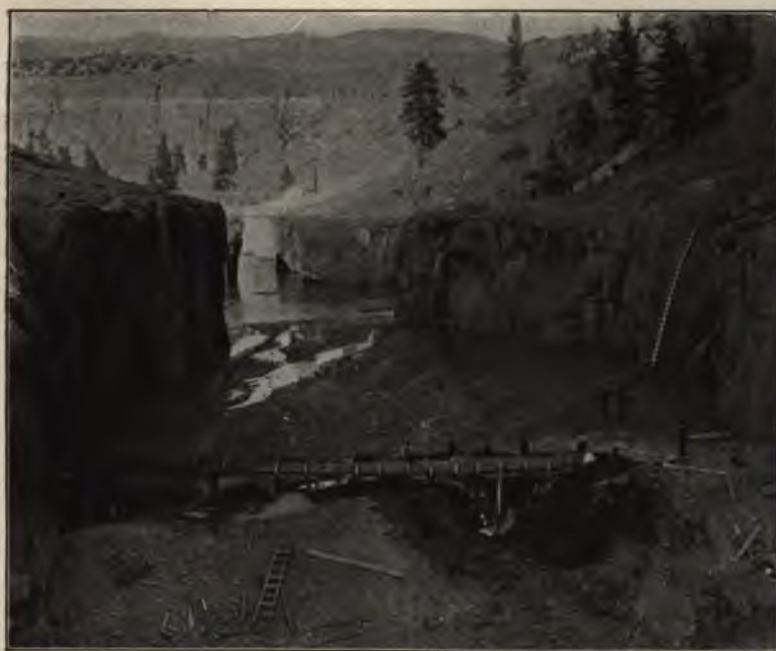
FIG. 105.—TERRACE DAM. DEPOSIT OF HYDRAULIC FILLING ON THE UPPER TOE SLOPE.

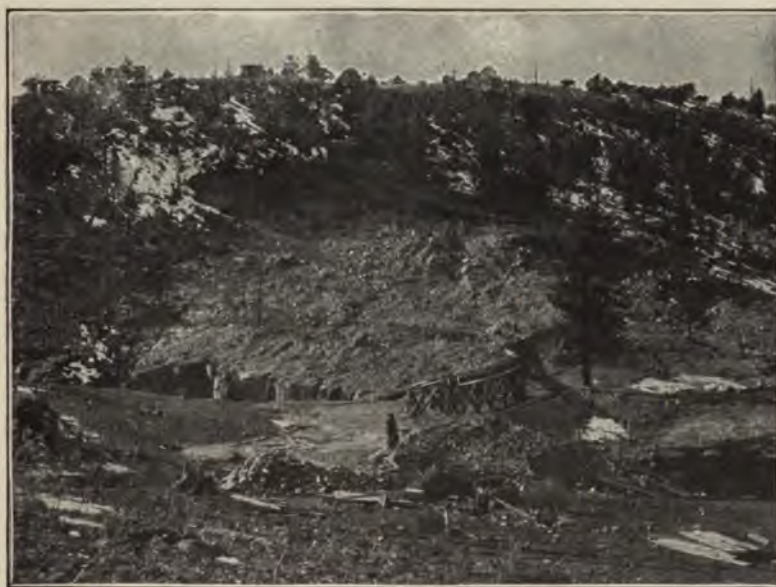
FIG. 106.—WASTEWAY FLUME FOR FLOOD DISCHARGE OVER LOWER SLOPE OF TERRACE DAM.
SUMMER OF 1907.

At the opening of the season of 1907, the company took over the contractor's plant and continued work through the season on its own account. Owing to the small size of the outlet tunnel, it became necessary to build a large flume (Fig. 106) over the top of the unfinished dam

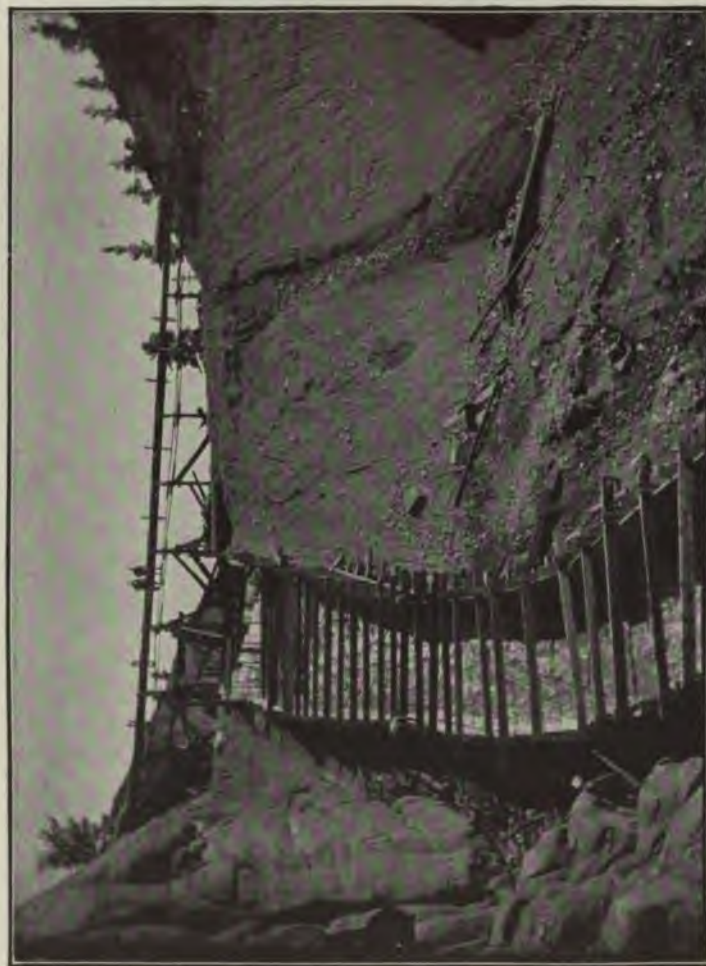
FIG. 107.—VIEW OF LOWER TOE FILLING, TERRACE DAM, COLORADO, SHOWING HYDRAULIC SLUICING IN BACKGROUND.

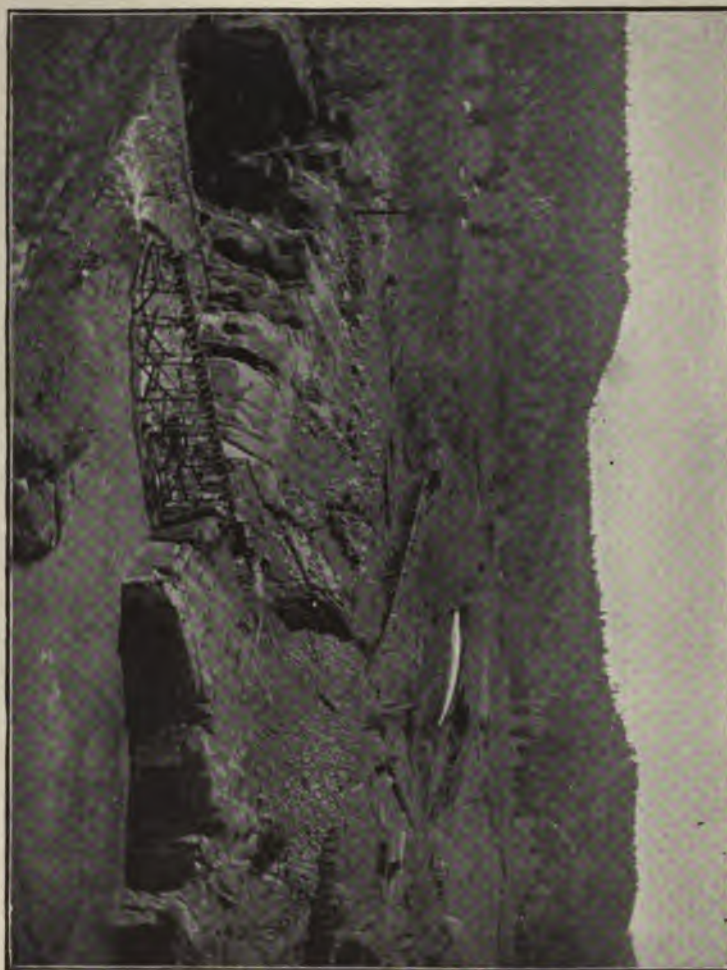
FIG. 109.—SANTO AMARO DAM, SÃO PAULO, BRAZIL. (1 MILE LONG.) SHOWING METHOD OF DELIVERY OF SLICED MATERIAL THROUGH FLUMES AND LATERALS.

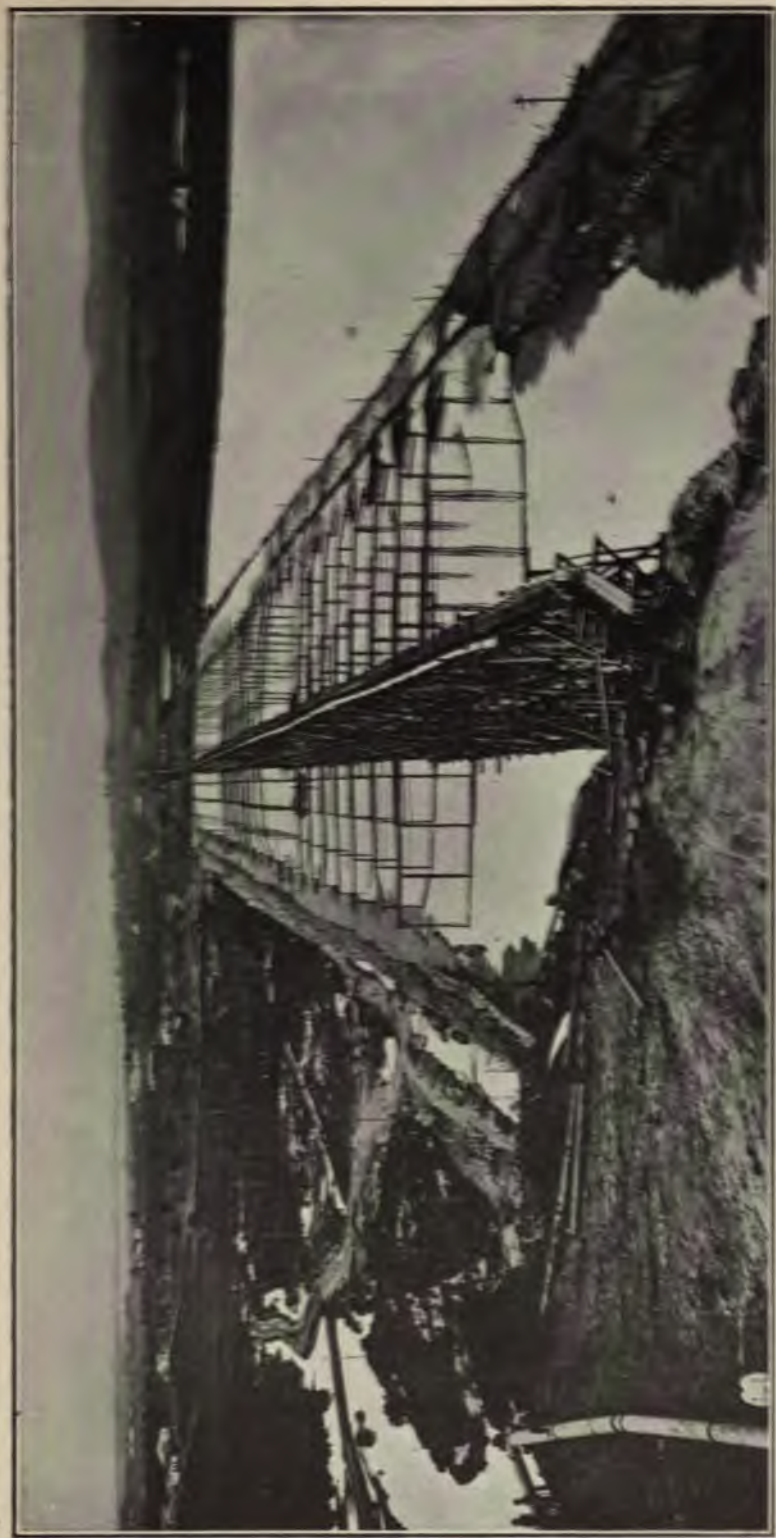
FIG. 109.—GENERAL VIEW OF SANTO AMARO DAM, BRAZIL, AUG. 21, 1907. SHOWING THREE LEVELS OF DELIVERY ON CENTRAL TRESTLE. TOTAL LENGTH 5300 FEET, MAXIMUM HEIGHT 63 FEET. TOTAL 148

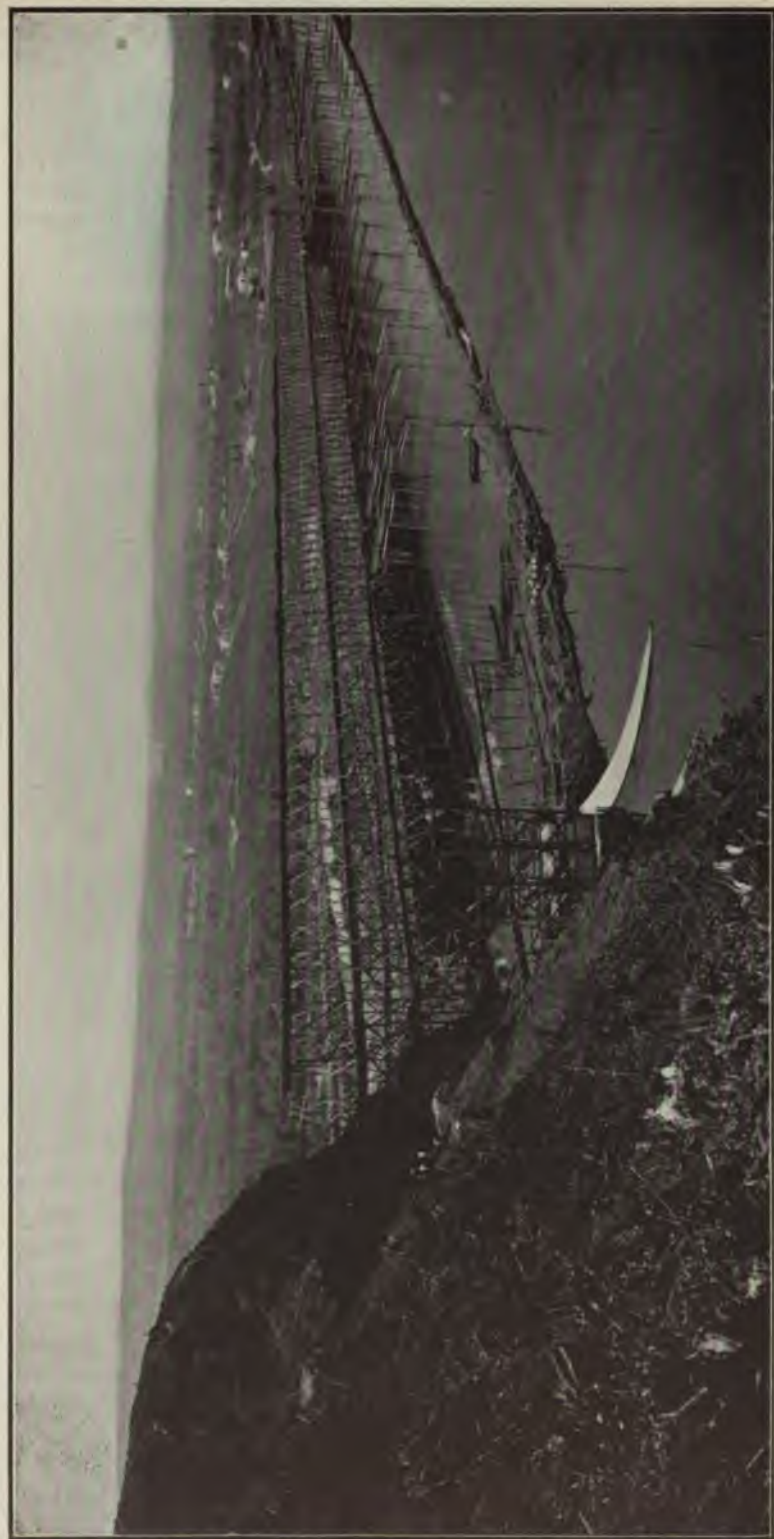
FIG. 110.—SANTO AMARO DAM, BRAZIL, SHOWING HYDRAULIC MONITOR AT WORK, DELIVERING 8 SECOND-FEET UNDER 85 POUNDS PRESSURE THROUGH 4-INCH NOZZLE.

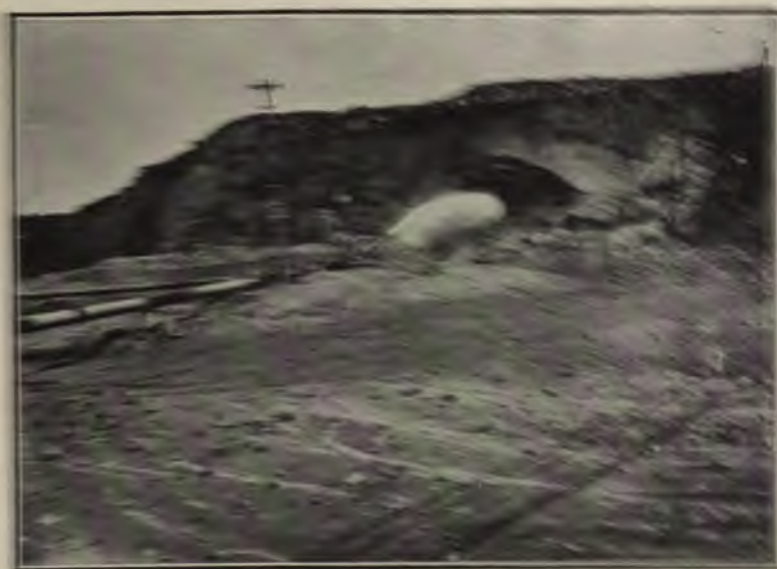
FIG. 111.—UPPER TOE FILLING ON THE SANTO AMARO HYDRAULIC-FILL DAM, BRAZIL, SHOWING LATERAL FLUMES.

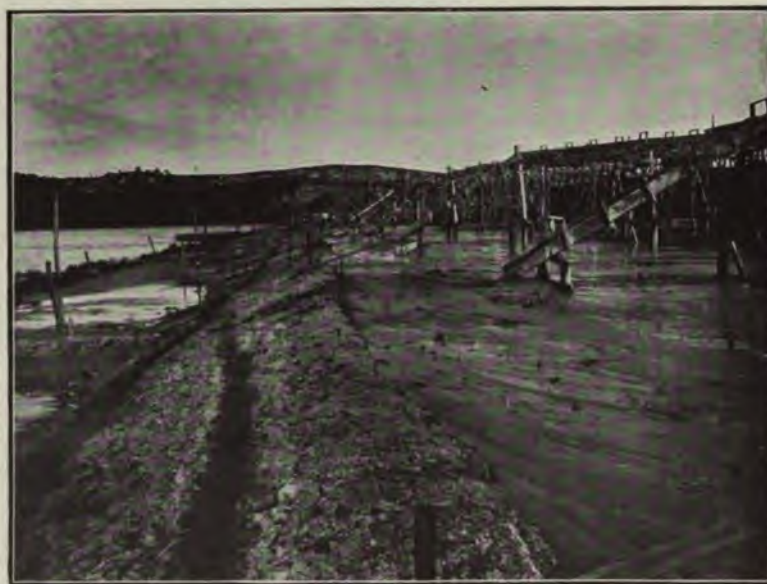
FIG. 114.—LOOKING UP STREAM AT SITE OF DAM NO. 2, AT NECAXA, SHOWING STRIPPED ABUTMENTS FOR THE DAM ON EACH SIDE.

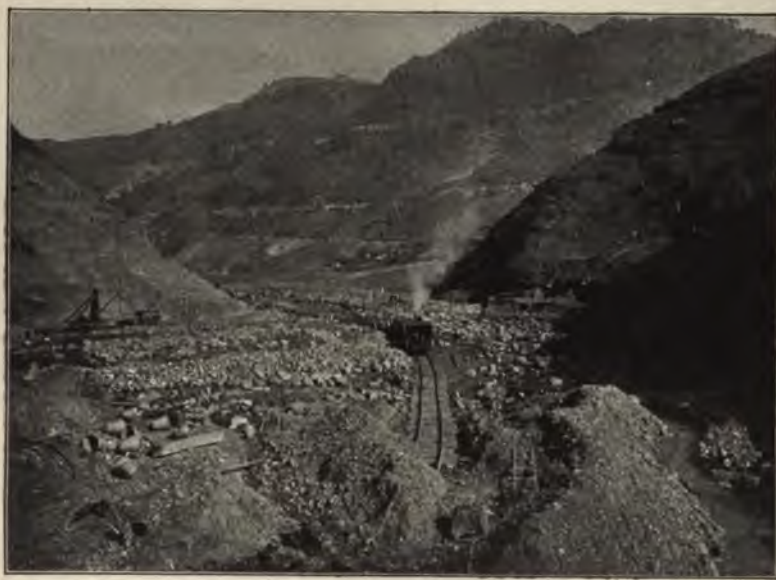
FIG. 115.—NECAXA DAM, MEXICO. HYDRAULIC MONITOR WORKING UNDER 180 POUNDS PRESSURE, 6-INCH NOZZLE, 30 SECOND-FEET OF WATER.

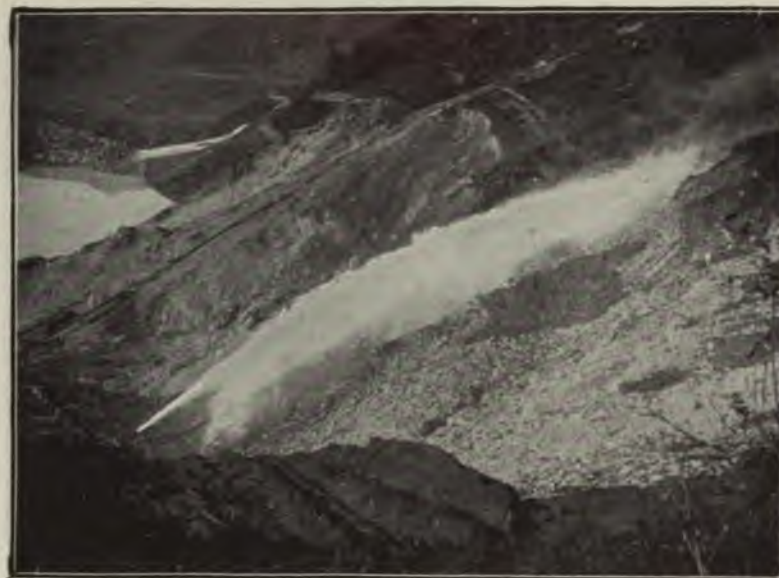
FIG. 116.—HYDRAULIC MONITOR IN ACTION, WITH 30 SECOND-FEET UNDER 180 POUNDS PRESSURE, 6-INCH NOZZLE. UP-STREAM TOE OF DAM SHOWN, WITH TAILING POND AT LEFT.

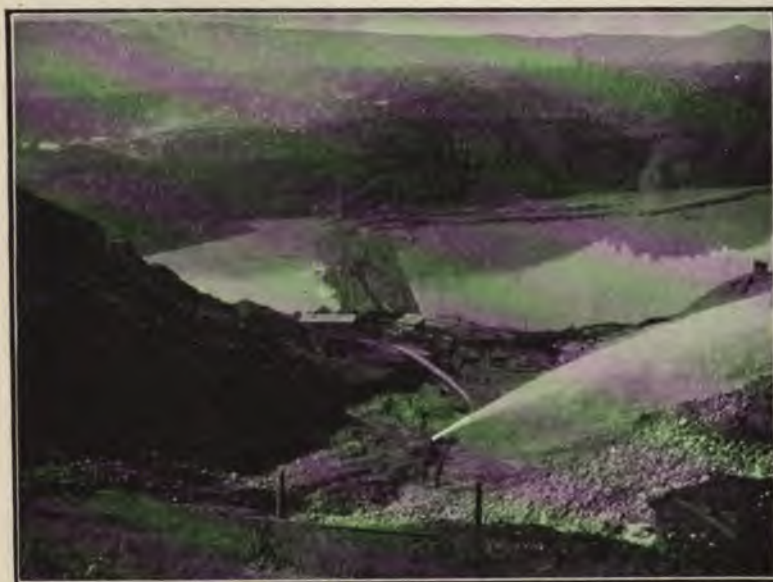
FIG. 117.—HYDRAULIC MONITOR WORKING ON LINE OF CONTACT BETWEEN LIMESTONE AND LAVA IN SPILLWAY CUT, NECAXA DAM, MEXICO.
